# Evolutionary interpretation of the landslides from the Miron Căproiu Street Scarp (Eternităţii Street – V. Alecsandri Street) – Breaza Town

Iuliana ARMAŞ\*, Răsvan DAMIAN\*\*

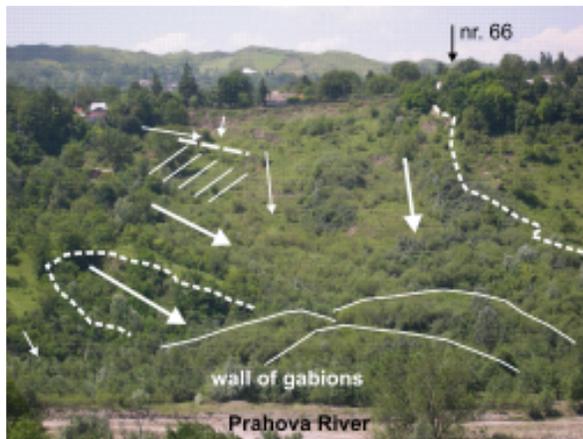
The steep slopes of terrace II (in the Miron Căproiu – A1 area) is shaped by a complex series of adventive, active landslides, centered on the main landslide (photo 1). The slope is fragmented by amphitheatre-shaped slide crevices, 10–15 m high. The slided material forms forested waves, covered by willow. Reactivations and slow movements appear especially in rainy years, affecting the street network. In the slope up to 5 m high secondary breaking crevices appeared, with a regressive development. As a consequence, the width of the street is reduced, locally to less than 2 m. In certain sectors, flowing slides or even mudflows also occur.

*Photo 1* The A1 landslide in July 2005, seen from the left bank of the Prahova (arrows show the main directions of movement, cross-hatching represents the T1 surface, continuous lines mark the contour of the main slide waves from the slope base)

The morpho-dynamical analysis shows a continuous retreat of the breaking crevices during the study period, especially in the central area, along the motorway. This process is countered by filling and consolidation of the motorway. The filling material breaks down in a ladder-like pattern, especially during the rainy seasons, when the surface drainage along the

The slided rock mass overstepped the structural ledge (shown as interrupted line in the photo) during the spring-summer of 2005, oriented by the gypsum levels. In the ledge a secondary breaking crevice developed.

The steps made up of the slided filling material falling periodically from the central breaking crevice accumulate at the base of the slope, being renewed during the rainy seasons. In the upper half of the landslide, the material moves along a direction controlled by the gypsum levels, then is reoriented to the Prahova Valley; there is a relative stopping period on terrace, at 30 m relative altitude. Field observations during the study period showed a removal of the material from the slide waves of the breaking crevice through drainage on the structural surface. A central, very active drainage alignment is obvious, being continuously supplied from the breaking crevice. The secondary landslide below house nr. 66 is less active.

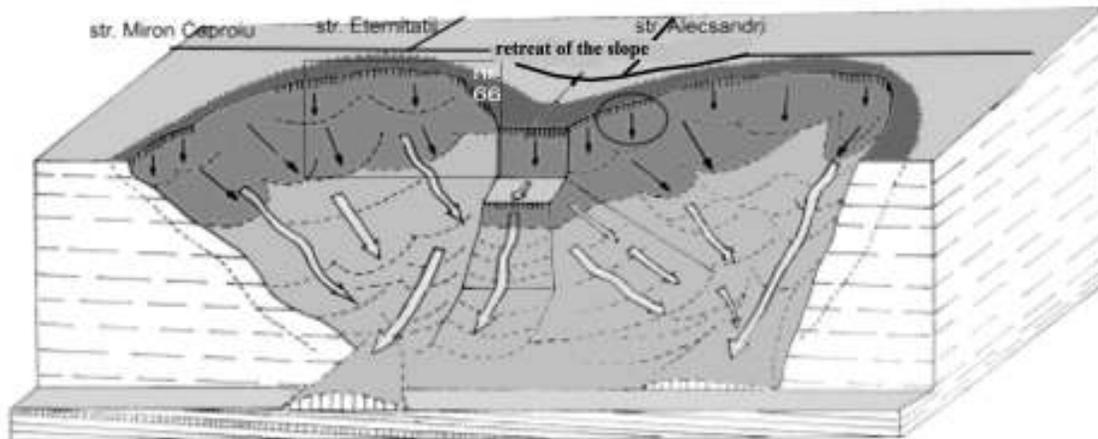
The analysis of the spatial and morphological features, as well as that of the flow directions and the stability of the slided masses, led to the identification of several genetical, morphological and morpho-dynamic models of the landslide. At the edge of the terrace, on the Miron Căproiu Street intersection with the Eternității Street, the studied landslide can be included in the model *M-A1* separated by the authors (Miron Căproiu – A1 landslide; fig. 1 and 2, see also Armaș et al., 2003).

Fig. 2 Model of evacuation of the deluvial mass, M-A1, as specific to the syncline flank

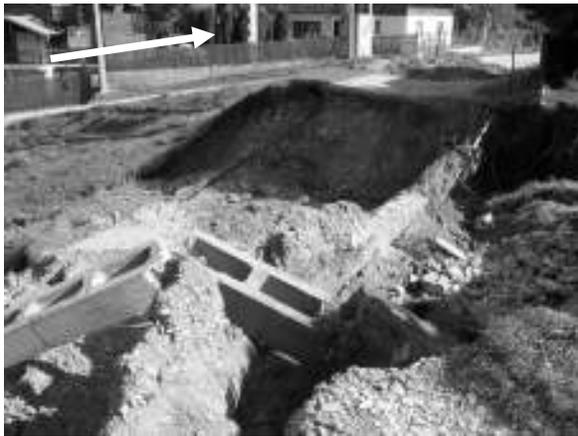
The evolution of the slope and development of the landslide during September 2005 was conformable to that proposed in the model developed (Armaș et al., 2003). Following heavy rains, a sudden collapse involving filling material occurred, leading to the destruction of the motorway, fall-out of an electric pole, destruction of a well and unearthing water pipes and electrical cables (photo 2).

**Photo 2** The landslide at the margin of the Alecsandri Street (September 2005); the paths of the pipes and electric cables that led to slope instability; in the right side, the cobbles of a well felt into the breaking crevice

The lithology, geological setting and field observations made the second day after the initialization of the September 2005 landslide (small, wet breaking crevices, sliding slopes, free-flowing water) suggest the presence of a process that threatens the stability of the foundation for an

electric pole and transform station from the side of the road.

Moreover, the position of this electric pole is further weakened by local instability factors due to constructions: almost horizontal leveling – without possibility of water discharge and covering with concrete of the courtyards, construction of transverse support walls; all these led to the build-up of a system that stores water under pressure (nr. 68 M. Căproiu Street). This water is partly discharging towards north (the plea of the landslide). The presence and fluctuations of this water volume are demonstrated by the existence of a spring within the courtyard of nr. 68 M. Căproiu Street (shown by arrow in photo 2). The excess water storage leads to instability of the area extending to the the Miron Căproiu Street. The landslide is very active and develops regressively within the terrace. Up to the fall of 2006, no security measures were taken to protect the area, except for a sidewalk fence.

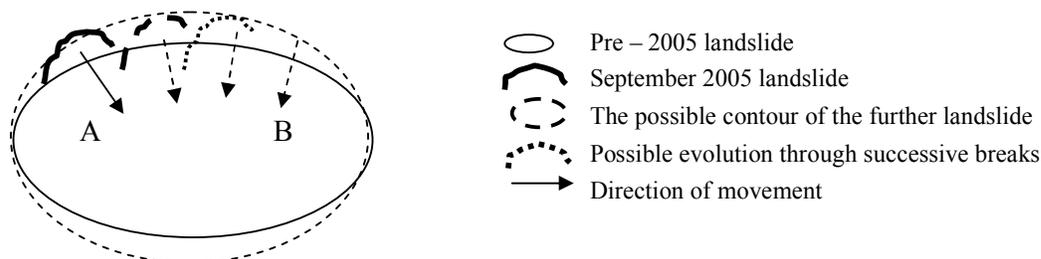
The „widely open embayment” contour, representing a level of relative equilibrium, is currently being remodeled by a new contour “invasion”. It is probable that this new, minor arch-shaped structure will continue its northward development. Some fissures evident in the motorway are already suggesting this trend (see fig. 3).

**Fig. 3** Probable evolution for the September 2005 landslide

From A to B (fig. 3), the arrow A shows the direction of the already started slide towards the distal part of the *breaking crevice arc*, *practically aligned with the axis of the road*.
