Rockfall Hazard Assessment

Case study: Lotru Valley and Olt Gorge*

Viorel ILINCA

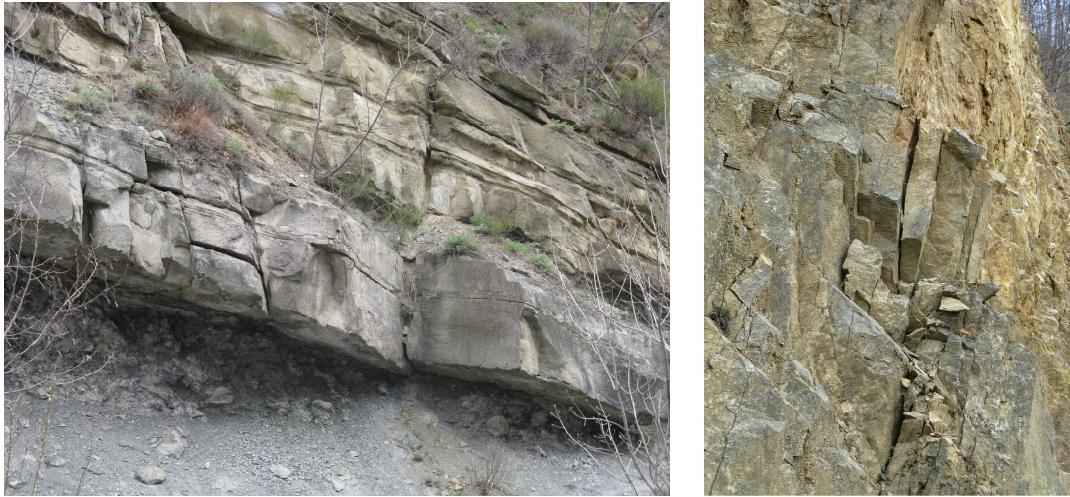
Fig. 2. Types of failure mechanism: overhanging block in sandstone (left) and topple in paragneiss

(microslope level for example). Generally large rockfalls are triggered under planar, wedge and overhang failures (Fig. 2). When joints have random orientation, the rock mass strength is lower and rockfalls occur.

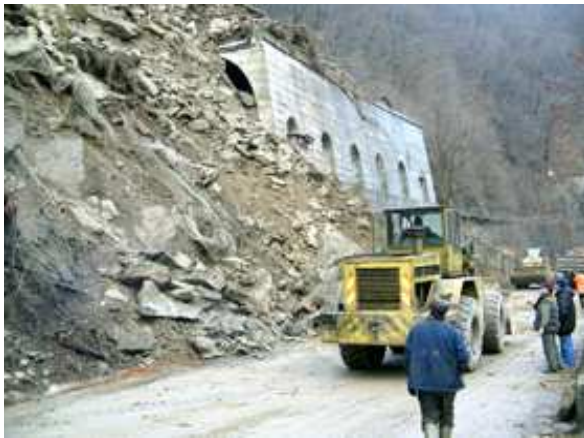
Fig. 7. Two major landslides: (a) the Căineni rock avalanche (Photo: Mediafax) and (b) the Latorița debris/rock avalanche

the European Road 81. Here, more than 7000 m³ (10000 m³ from another source) were detached from a 40-50 m high cliff and covered the railway and the road on a more than 30 m distance (Fig. 7 a). This was a typical rock avalanche. The European Road was turned-off between December 28, 2005 and 11 January, 2006 and the financial loss was also very high. At the time when the rock avalanche was triggered, a train was in the proximity of this point.

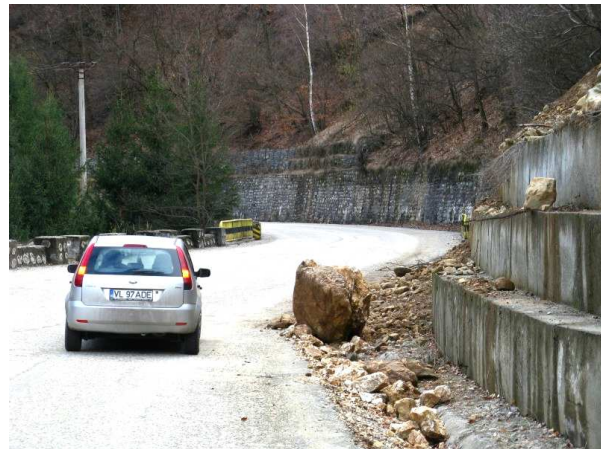
Fig. 8. The rockfall event, from March 8, 2009, along the National Road 7A (Lotru Valley). The blocks in the left photo have about 20 m³ and covered part of the road (the photo was taken after the authorities unblocked the road); the boulder from the right photo has a 1.5 m diameter

Secondly, it is the case of the transition seasons with freeze-thaw cycles, especially November, February and most of all March (Fig. 5). The last month has a high frequency of rockfalls due to the events that occurred on March 8, 2009, when we found 17 points with blocks on the road (Fig. 8). In our data base there are many multiple-occurrence events in both valleys.
