# Land degradation in the lower catchment of the Crasna river (Central Moldavian Plateau)

Petronela DARIE (CHELARU)<sup>1</sup>, Ion IONITA<sup>1</sup>

**Abstract.** Land degradation has been recognized as an important environmental threat in the Moldavian Plateau of eastern Romania. The cumulated action of natural factors, especially the coupling of the Kersonian sandy-clayey facies and the hilly fragmentation as well as anthropogenic ones resulted in triggering degradation processes, especially soil erosion, gullying and landslides. In addition, another issue of interest is the reservoir sedimentation.

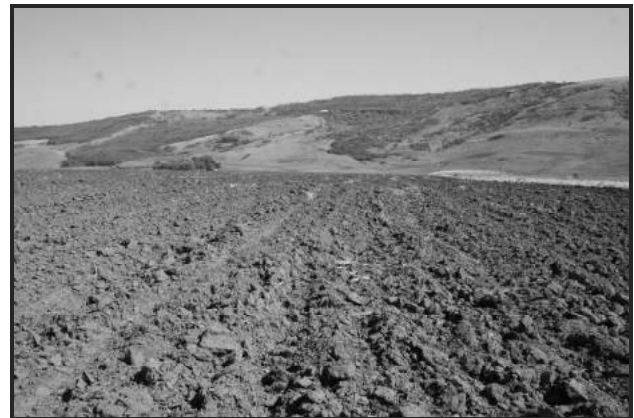
Fig. 2. Cuesta landforms along the resequent Burghina Valley. Eastern looking cuesta backslope in the foreground and western looking cuesta front in the background (October 1<sup>st</sup> 2011).

Taking into account the ENE-WSW orientation of the lower Crasna valley, one of the most representative examples of cuesta landforms occur associated to its subsequent position. Thus, the left valley-side is a vast cuesta front (antidip slope) facing NNW, almost uniform, while the right valley-side exhibits a very broad cuesta backslope (dip slope) looking SSE and deeply incised by resequent tributaries. At their turn, the valleys of those tributaries display the structural asymmetry by second degree, where typical are a westward looking cuesta front on the left valley-side and an eastward facing cuesta backslope on the right valley-side (Fig. 2). Those two systems of cuestas are associated with the double dipping of the underlying strata to the south and to the east, and from their combination the general homocline structure is resulting (Ionita, 1998, 2000a).

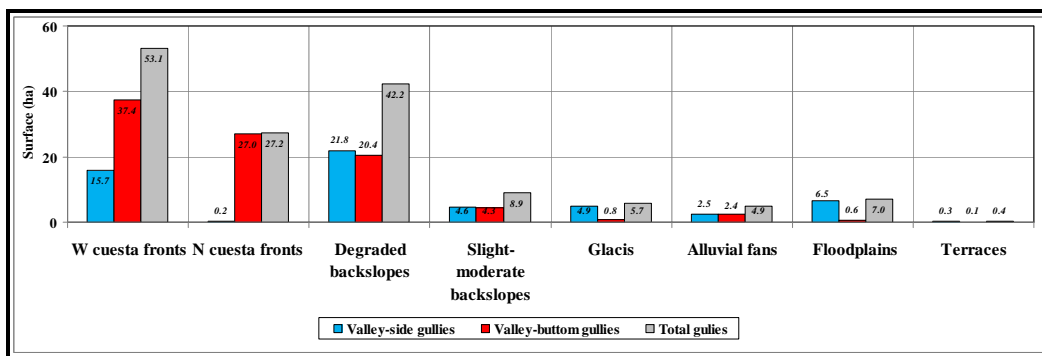
Fig. 8. The histogram of surfaces under gullying for each landform

The most significant areas affected by gullying are found on the cuesta fronts and on the highly degraded backslopes, while on hilltops, structural-

lithological plateaus and terraces, gullies are very poorly represented (Fig. 8).

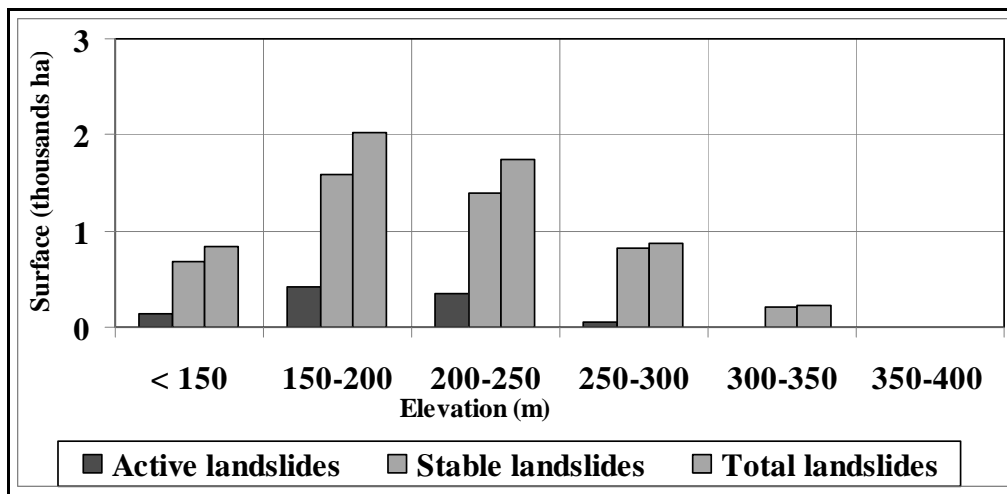
Fig. 10. The histogram of areas under landslides by elevation classes

The most sensitive slopes to landslides are found where the elevation varies between 150-250 m, and

the slope angle is above 25% (Fig. 10). By far, the northern and western looking cuesta fronts are subjected to moderate to deep-seated landslides covering about 4 165.5 ha (73% of the total area under landslides); the most affected are the Crasna, Burghina and Bălțați cuesta fronts (Fig. 11). They also develop on highly degraded backslopes.

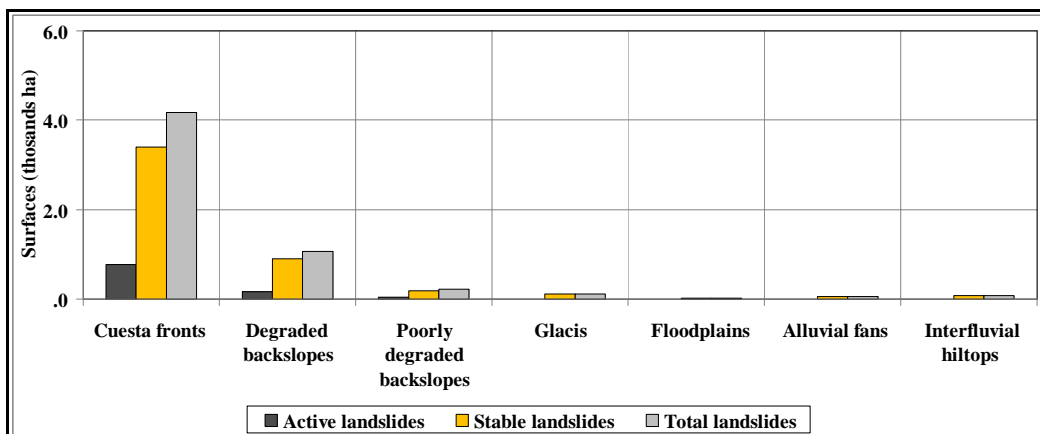
Fig. 11. The histogram of surfaces affected by landslides for each landform

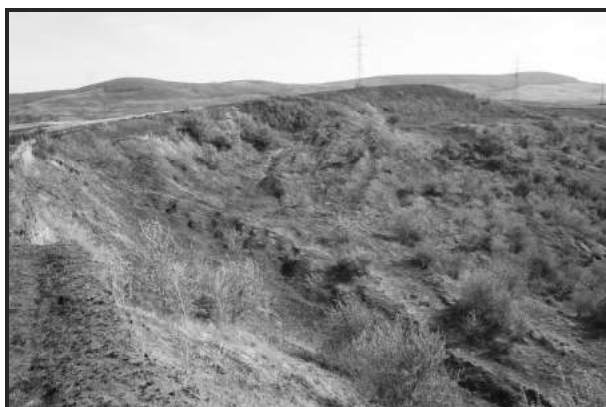
Fig. 12. Simple landslide *hartop* (amphitheatre) on the left valley-side of the Crasna at SSW of Vinetesti. In the background the Lohan Valley appears (October 3<sup>rd</sup> 2013).

Morphologically, many landslides in the study area are mixed, usually as step-like and waves-like landslides but the most typical are landslide amphitheatres, locally called *hartop* (Fig. 12).
